Manhole Inspection Summary

Manhole # S49K__004MH

Insp Date: **2/6/09 1:07 PM**

Location Address: **2342 FLEET ST** Cross Street: **S MONTFORD AV**

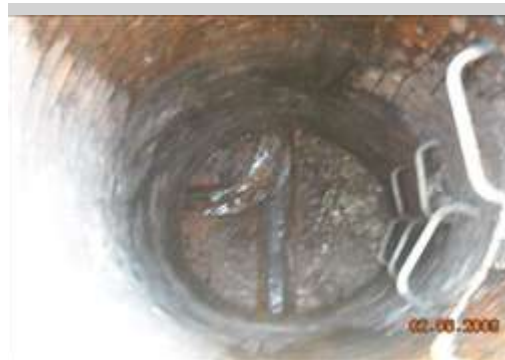
Top View

Comments **BROKE AND REPLACED 24 INCH COVER (see photos)**

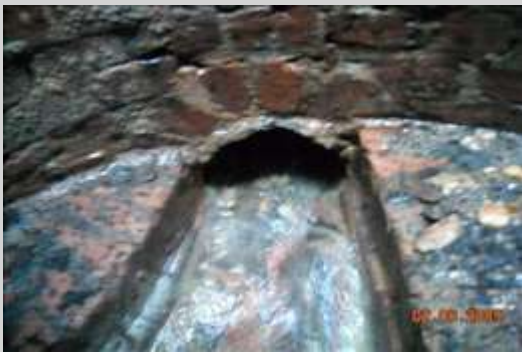
12 O'Clock Outflow

8 in. Circular Gravity Sewer
Pipe Out @ 12 O'Clock

Pipe Height: **8.4** (in.) Rod and Bar (Angled)
Pipe Material: **Clay** ☐ Pipe Lined
Invert Depth: **11.62** (ft.) Flow Characteristics: **Fast**
Deposits: ☒ None ☐ Mud ☐ Sludge ☐ Debris ☐ Grease
Silt Depth: **0** (in.) Deposits Extent:
Infiltration: **None** Pipe Seal Cond: **Sound**

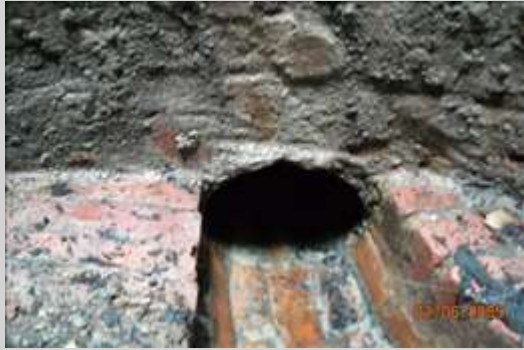
9 O'Clock Inflow

8 in. Circular Gravity Sewer

Pipe In @ 9 O'Clock

Pipe Height: **8.4** (in.) Rod and Bar (Angled)

Pipe Material: **Clay** ☐ Pipe Lined

Infiltration: **None** Pipe Seal Cond: **Sound**
